101 Main Street, Dublin GA, 31021  
Inspection prepared for: Mary Smith  
Agent: Fain Powel - Curry Residential

Inspection Date: 1/1/2011 Time: 9:00 AM  
Weather: Sunny / Warm

**EMERALD CITY INSPECTIONS, LLC**

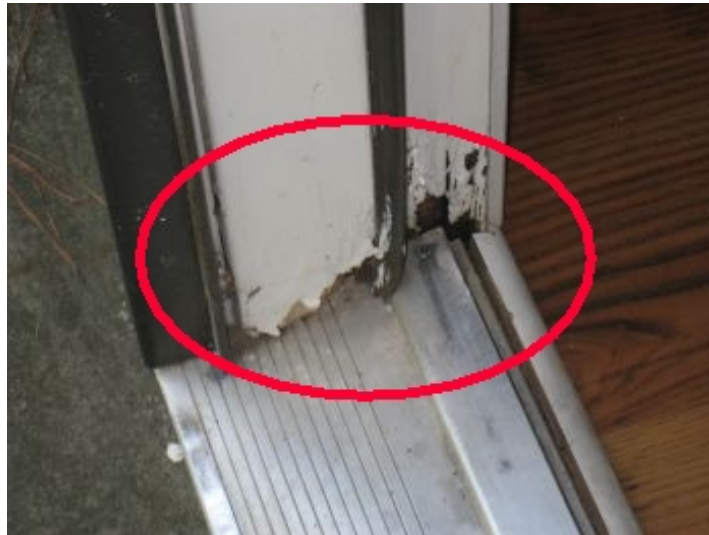
- MAINTENANCE : Wooden trim around rear exterior door is rotting at bottom. Repair, prime and paint as required

Water damage at bottom of rear door

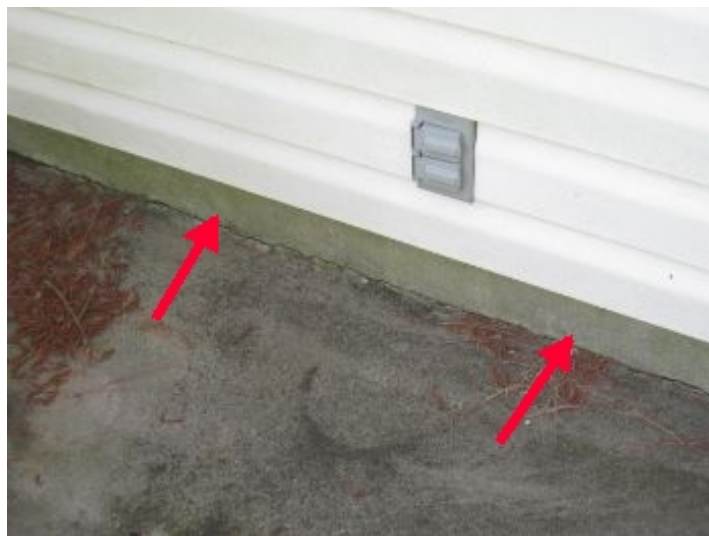
- IMPROVE: Typical cracking was observed at joint between patio and house. Recommend sealing the cracks to prevent water infiltration.

Caulking recommended at patio

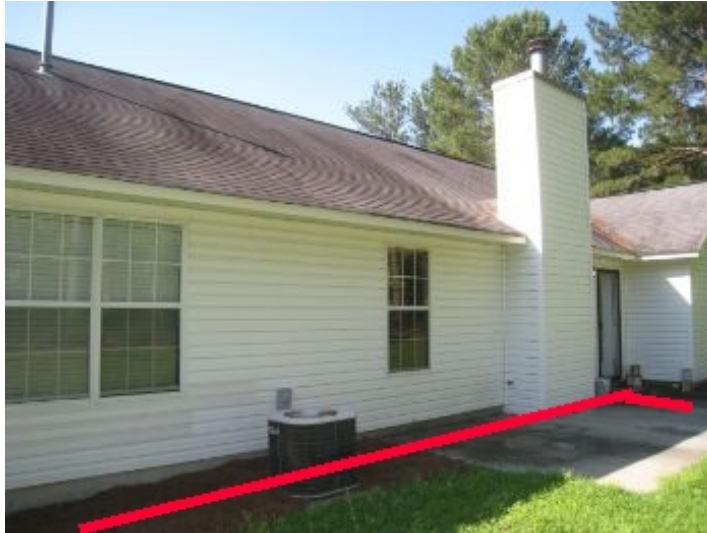
- FYI : Lot grading and drainage have a significant impact on the building, simply because of the direct and indirect damage that moisture can have on the foundation. It is very important, therefore, that surface runoff water be adequately diverted away from the home. Lot grading should slope away and fall a minimum of one (1) inch every foot for a distance of six (6) feet around the perimeter of the building.
- IMPROVE : Low and settled grading at the rear of the house. Water can intrude under the house, possibly affecting the foundation, or causing other water-related problems. The client should consider installing gutters in the area and making drainage modifications to remove water coming from the yard and roof.

Rear roof drainage area

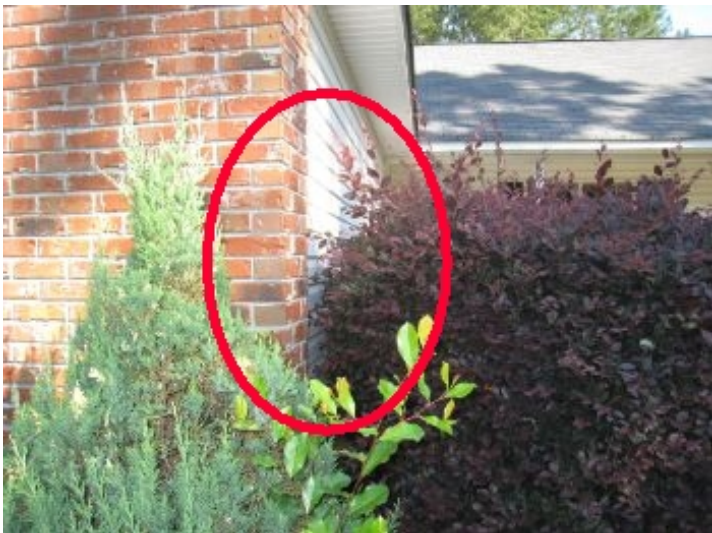
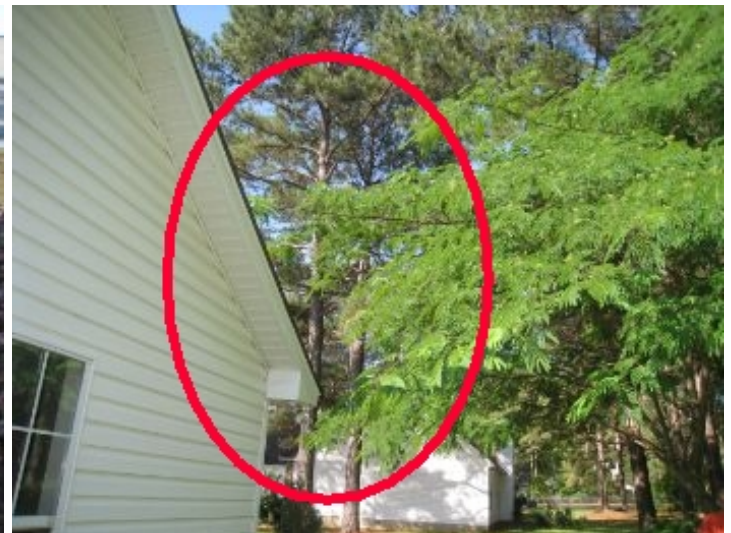
- Trees are in contact with, or are close to, the roof in one or more areas. Damage to the roof may result, especially during high winds. Trees should be pruned and/or removed as necessary to maintain approximately 10 ft. of clearance.
- Recommend having vegetation trimmed, pruned, or removed from affected areas, and regular homeowner monitoring and landscaping maintenance thereafter to maintain at least 12" of clearance.

Vegetation against structure

Tree near structure

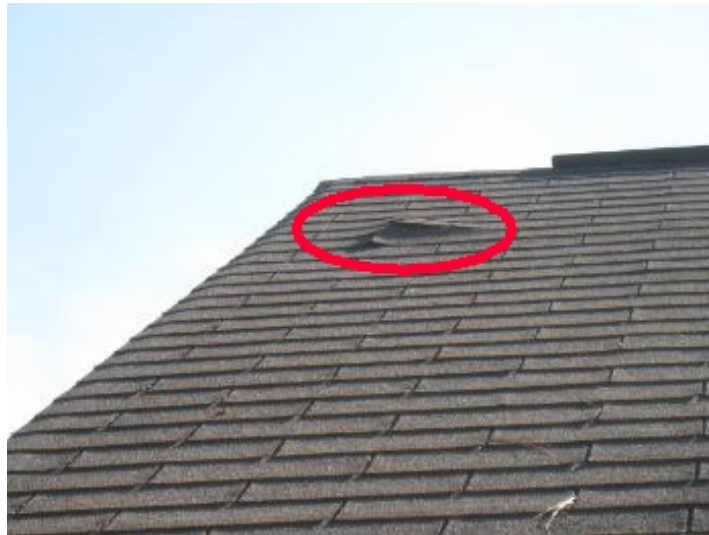
- Roof appeared to be in serviceable condition.
- FYI: Once a roof reaches the ten (10) year mark, it is a good idea to have the roof inspected for any signs of aging every three years. A roof that has some routine maintenance in its second half of life will outperform those that are not maintained.
- Roofing is not lying flat in one area. A qualified roofing contractor should evaluate and repair.

Roof repair required

Roofing		
Page 8 Item: 2	Roof Covering	<ul style="list-style-type: none"> <li>Roofing is not lying flat in one area. A qualified roofing contractor should evaluate and repair.</li> </ul>
Garage/Carport		
Page 12 Item: 3	Garage Door Safety Features	<ul style="list-style-type: none"> <li>The electric eye reversal for the door did not reverse the door when tested. The door opening system should be repaired by a qualified technician before using the garage.</li> </ul>
Electrical		
Page 15 Item: 5	Main Service Panel(s)	<ul style="list-style-type: none"> <li>One or more romex cables enter the panel through unprotected knockouts. This may cause wire damage and should be repaired by a qualified electrician.</li> <li>Neutrals and/or grounds are improperly attached in the main panel. Have an electrician properly separate.</li> </ul>
Page 15 Item: 7	Wiring Methods	<ul style="list-style-type: none"> <li>The power supply wiring for the electric range is improperly installed (not secured to the wall). This condition should be reviewed and corrected by a qualified electrician.</li> <li>Extension cord wiring used as permanent wiring located in one or more locations. Extension cords are designed for temporary usage. Recommend removal or to have the fixtures hard wired by an electrician.</li> </ul>

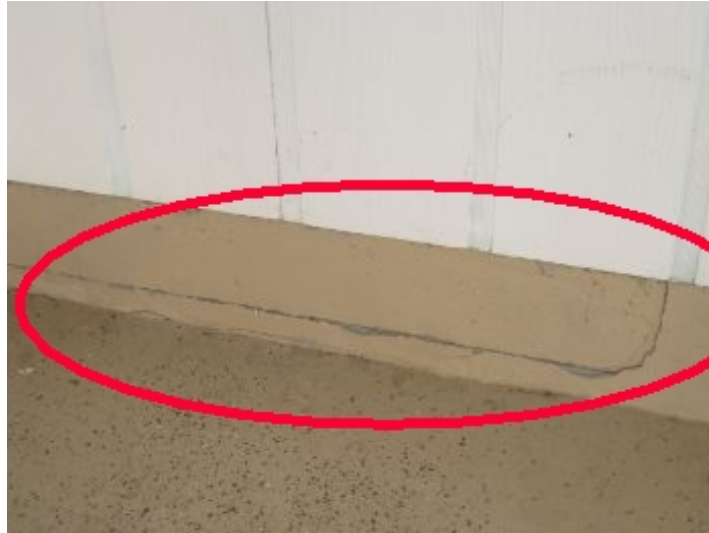
- Apparent impact damage observed at foundation between garage and home. Monitor and repair if additional deterioration occurs.

Apparent impact damage in garage

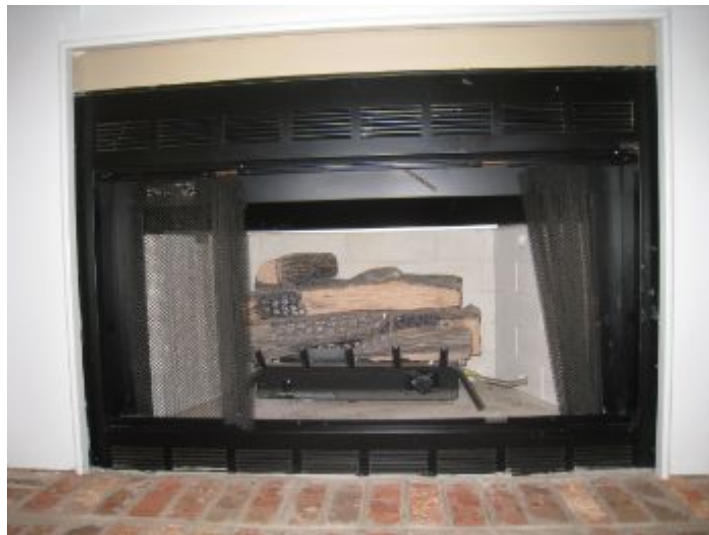
- Visible portions of the fireplace and chimney appeared to be in satisfactory condition at the time of inspection.
- FYI : It appears that the fireplace has never been used.

Fireplace with gas logs

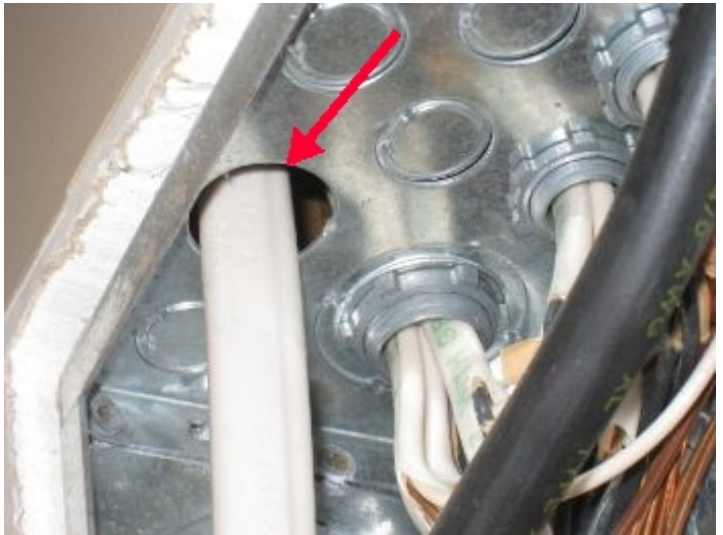
- One or more romex cables enter the panel through unprotected knockouts. This may cause wire damage and should be repaired by a qualified electrician.
- Neutrals and/or grounds are improperly attached in the main panel. Have an electrician properly separate.

Improper neutral terminations

No cable protection in opening

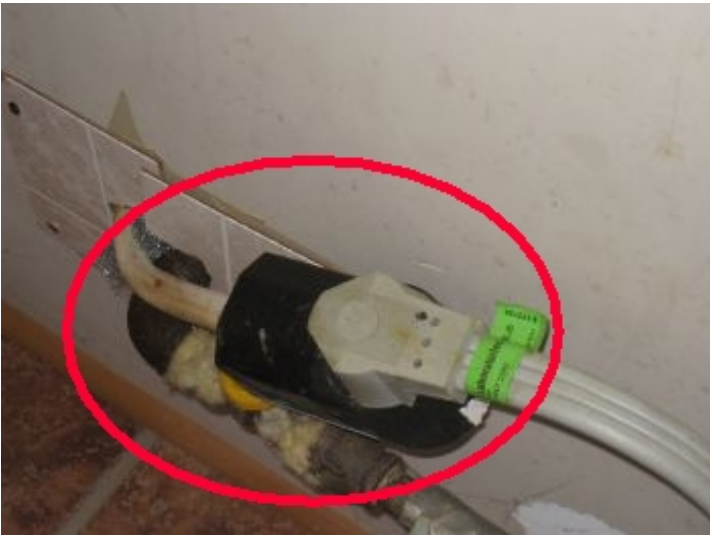
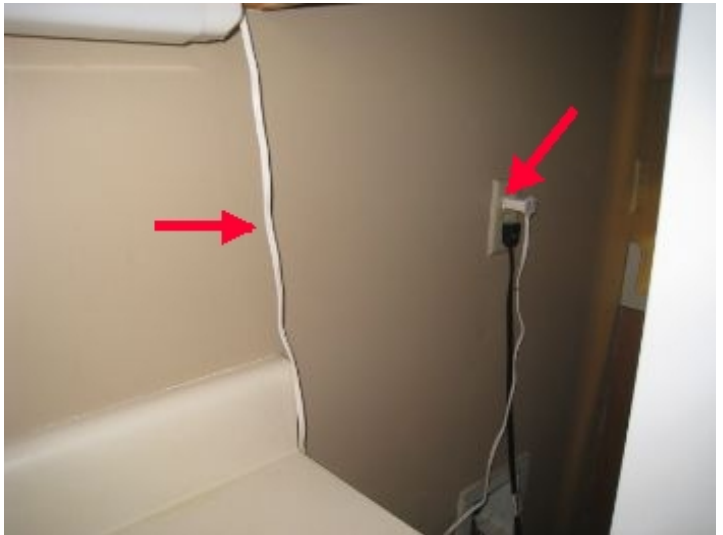
- The power supply wiring for the electric range is improperly installed (not secured to the wall). This condition should be reviewed and corrected by a qualified electrician.
- Extension cord wiring used as permanent wiring located in one or more locations. Extension cords are designed for temporary usage. Recommend removal or to have the fixtures hard wired by an electrician.

Improper wiring for range

Extension cord used for permanent wiring in kitchen

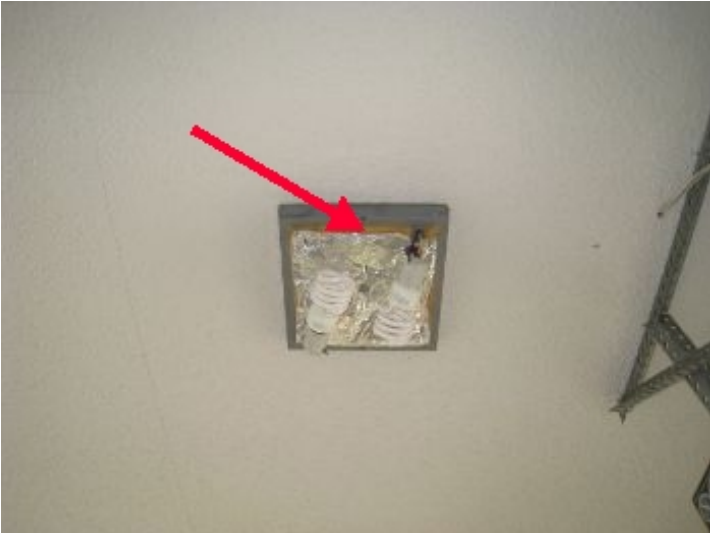
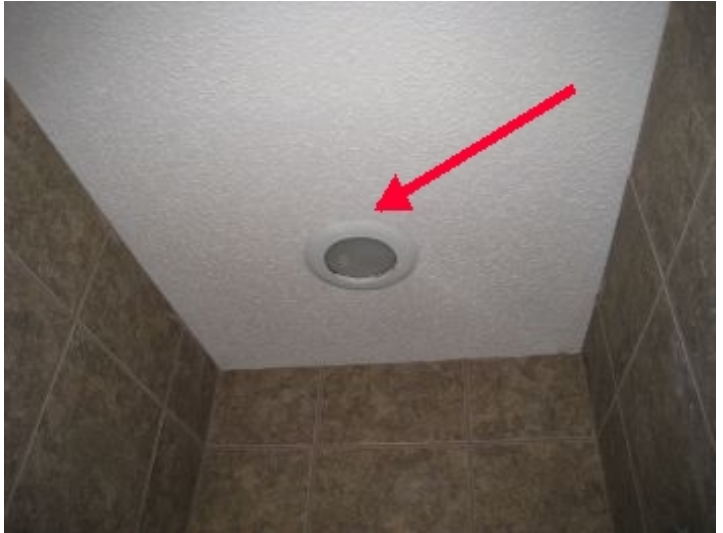
- A representative number of receptacles, switches and lights were tested and are generally serviceable.
- Numerous light bulbs were apparently in need of replacement.
- Fixture cover is missing in garage. The cover (or the entire fixture) should be replaced.
- Bathroom shower light is inoperable. Repair.

Missing fixture cover in garage

Inoperable light in master bathroom shower

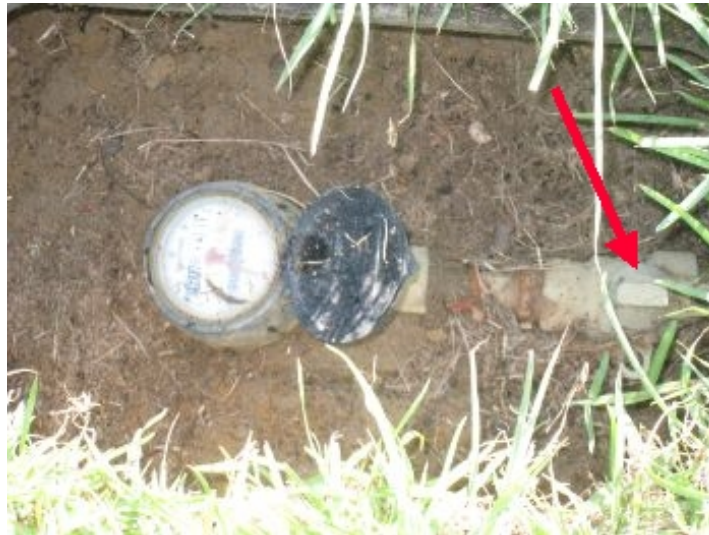
- No deficiencies observed
- FYI : The main shutoff valve requires a special tool ("curb key") for operation (available at home supply stores). It is recommended that one of these tools be kept in a readily accessible location for use in the event of a plumbing emergency.

Water meter and main shut-off valve

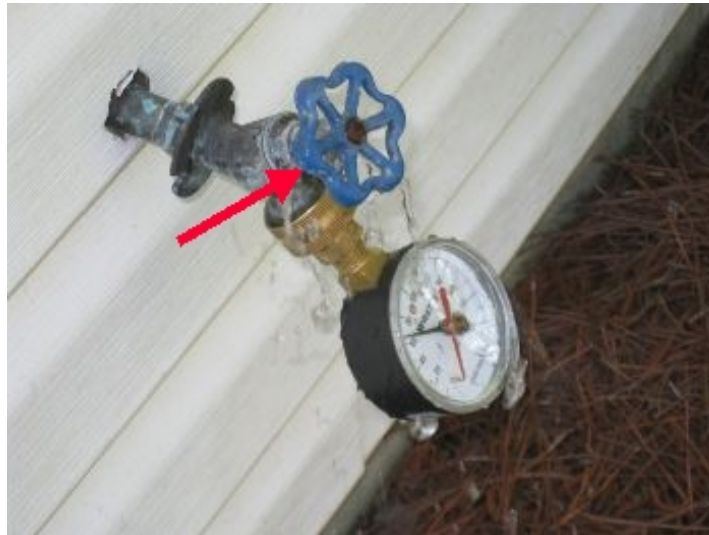
**Observations:** One or more hose bibs leaked badly around the stem when in operation. Repair.

Leaking hose bib

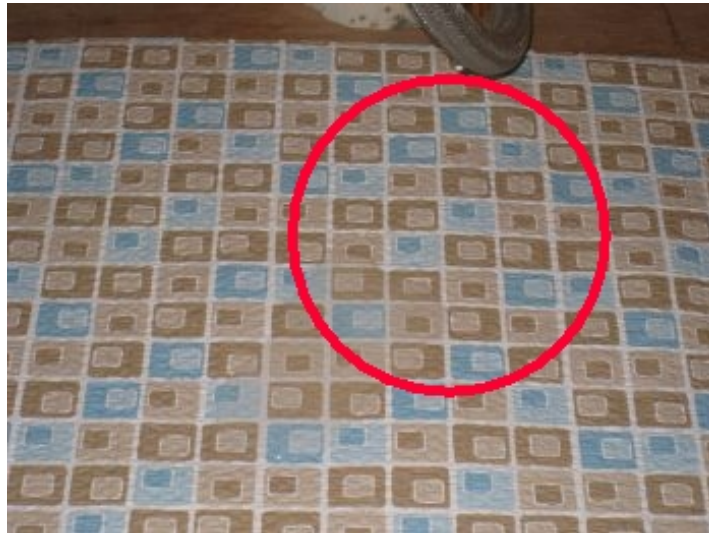
- Faucet at kitchen sink may be leaking; water was observed in the cabinet below. Repair or replace as required.
- Hot/cold reversed plumbing observed at whirlpool tub. Recommending swapping knob labels as the most practical solution.

Water leak under kitchen sink

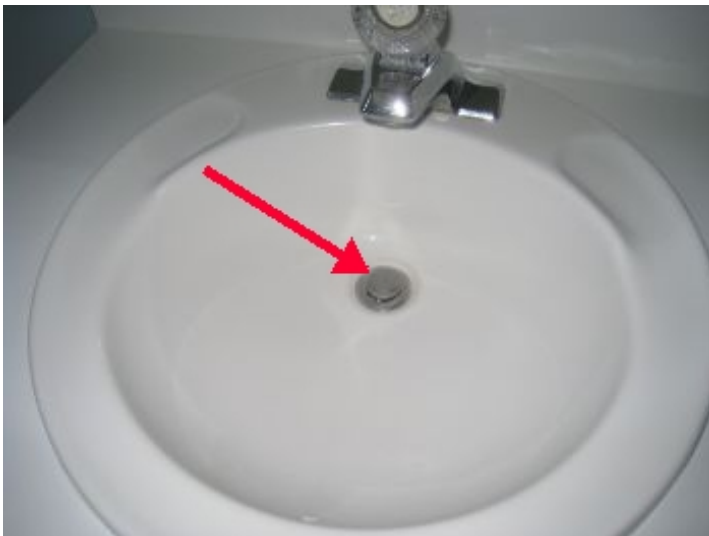
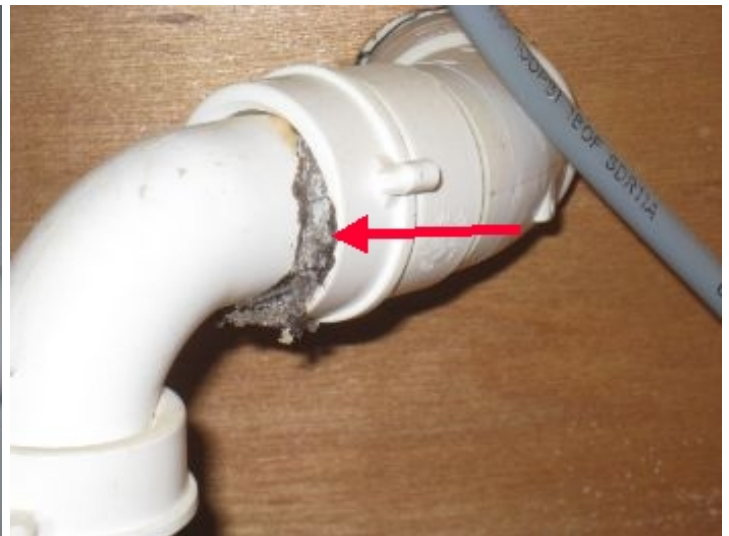
Observations:  
• Water was run through the fixtures and drains. Functional drainage was observed.  
• The pop-up drain stopper was not operable in one or more bathroom sinks. See photos.  
• A leak in the drain piping under the left sink in the hall bathroom should be repaired.

Inoperable pop-up drain in hall bathroom

Leak in hall bathroom drain

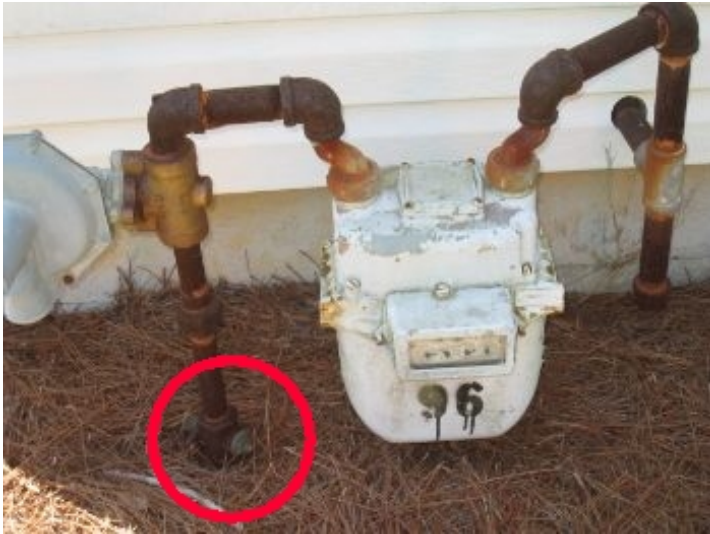
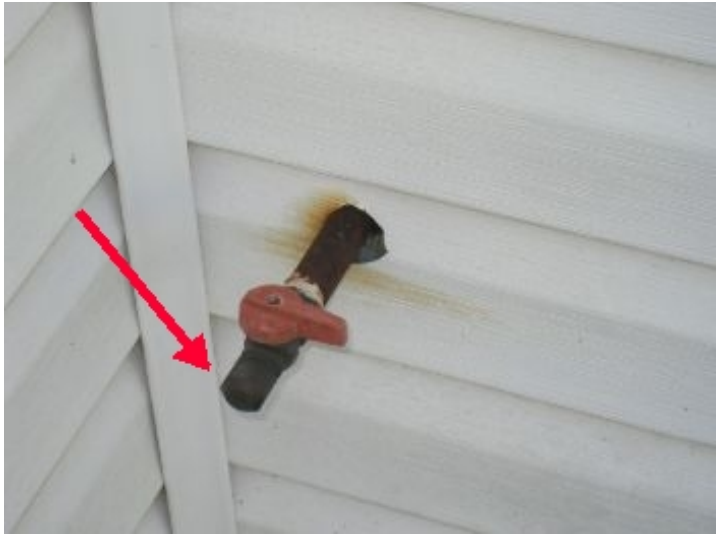
- Meter located at exterior. All gas appliances have cut-off valves in line at each unit. No gas odors detected.

Gas meter and main shut-off

Gas connection for outdoor grill

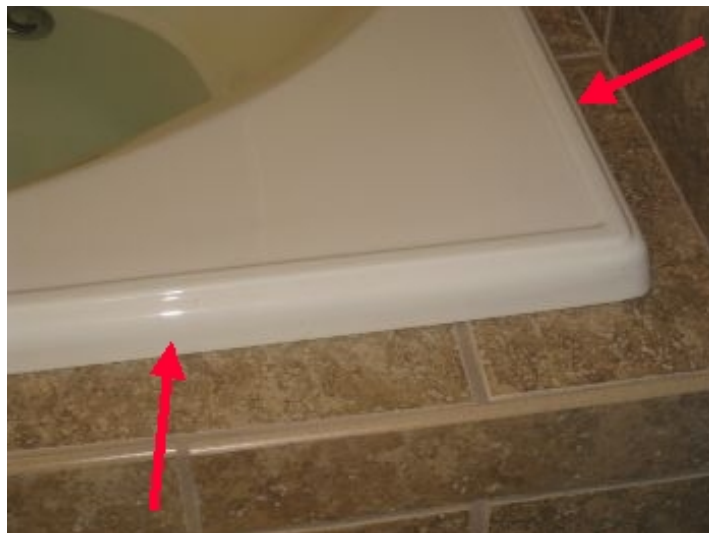
Caulking recommended at whirlpool tub

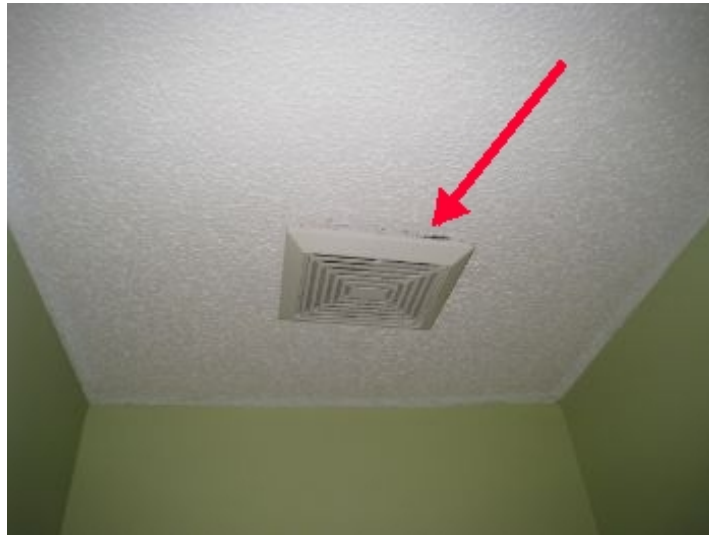
- Appeared functional at time of inspection.
- IMPROVE: The bathroom exhaust fan vent(s) appear to terminate in the attic (some exhausts may be covered by insulation). This can cause a buildup of moisture and eventually mold in the attic. All house vents should be directed and vented towards the exterior of the structure. A qualified contractor should repair as needed.

Unsecured exhaust fan (master bathroom)

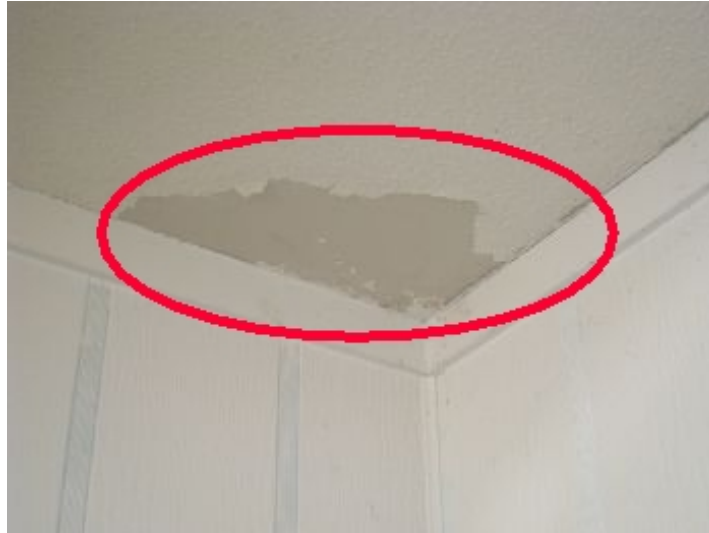
- Some cosmetic, common small cracks and typical flaws in drywall finish noted. This is normal wear for age of home.
- Some deterioration of the ceiling finish was observed in the garage. Repair and repaint, if desired.

Ceiling damage in garage

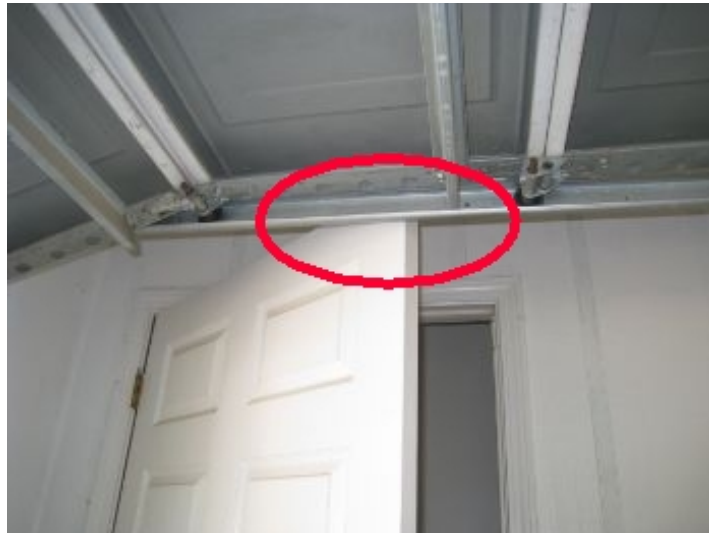
- FYI : Garage door track interferes with the utility room door.

Utility room door / garage door interference

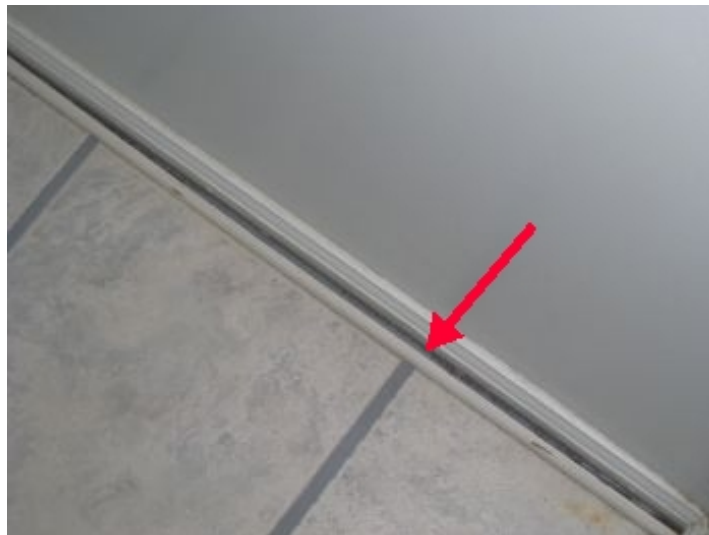
Observations: Loose shoe molding in hall bathroom closet should be properly installed.

Loose shoe molding in hall bathroom closet

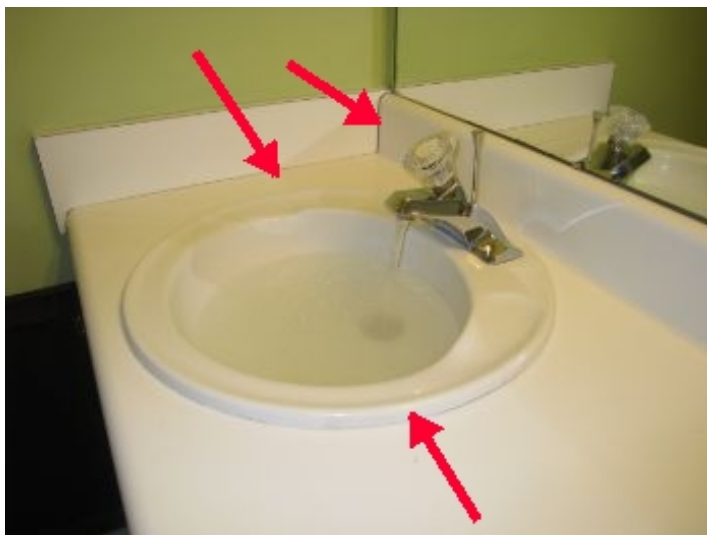
- Caulking recommended where vanities meet the backsplash and wall to prevent water damage.

Caulking recommended

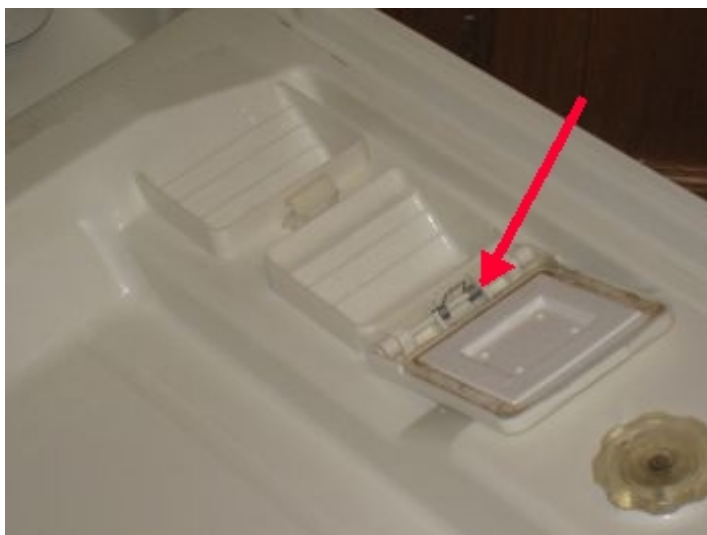
- Detergent door did not open properly during wash cycle. Repair

Dishwasher detergent door
